Technical BULLETIN

2007 PZ50W/FXW/GTW/MW/VTW Hard Starting in Extreme Cold Temperatures

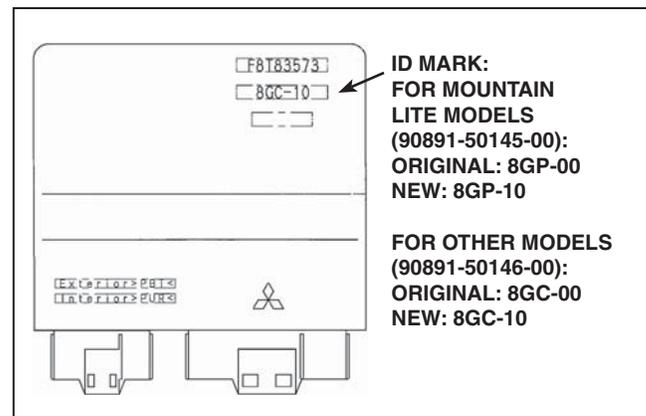
If you encounter an unfamiliar unit and you are unsure if the unit has been modified, check the ECU (see adjacent illustration).
