Technical BULLETIN

2007 PZ50W/FXW/GTW/MW/VTW Hard Starting in Extreme Cold Temperatures

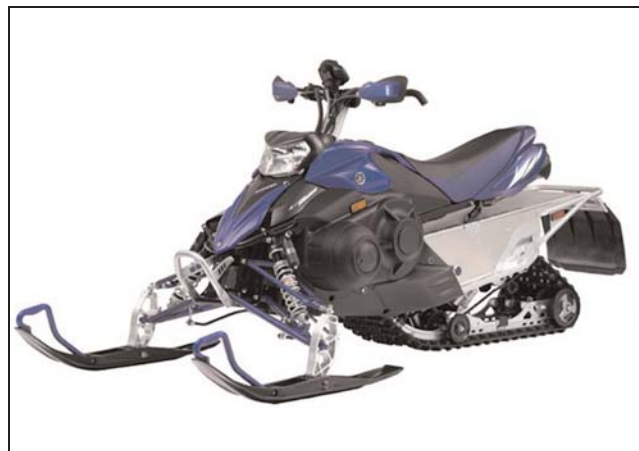
Symptom: Some affected units have experienced hard starting in temperatures below -15°F (-26°C).

Cause: Reduced engine cranking speed in extremely cold temperatures affects the engine decompression and ECU calibration. This can reduce the engine starting performance.

Remedy: Install ECU kit, which includes a new ECU, two decompression springs, and a cylinder head cover gasket (see *Parts Information* section for more details).
