Technical BULLETIN

ALL 2008 PZ50GTX/MTX MODELS

Insufficient Heat Output from Grip Warmers

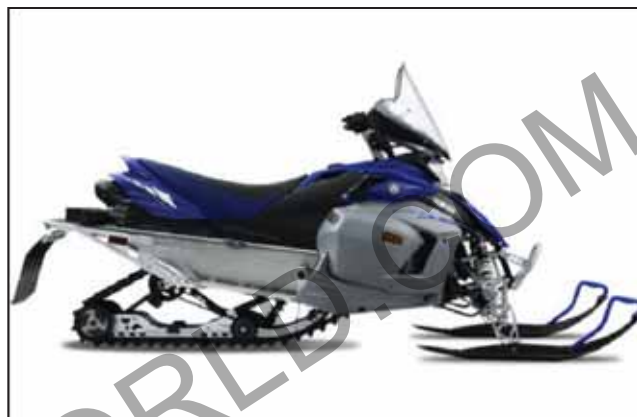
Symptom: On affected models, the grip warmer heat output may be insufficient at the higher heat settings.

Cause: During assembly, a sub-harness wire was not installed in the main wire harness.

Remedy: Install the missing grip warmer sub-harness to correct the wiring for the grip warmers during unit assembly and Pre-delivery Inspection (PDI) as per this bulletin.

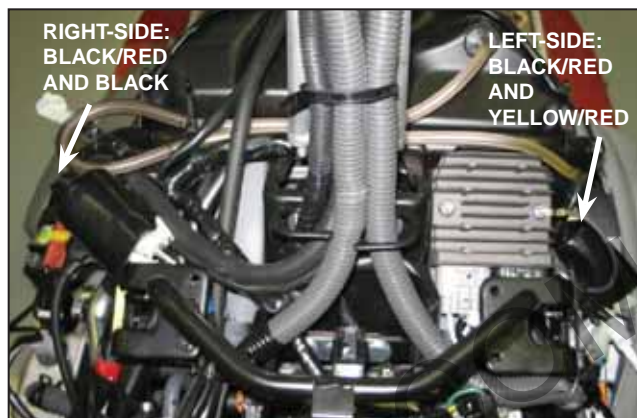
NOTE: The left side main harness connector wire colors are Black/Red and Yellow/Red. The right side are Black/Red and Black

1. Remove the windshield.
2. Remove the headlight cover. Remove the 3 bolts, on each side of the unit, to remove the left and right side panels.
3. Remove the headlight assembly and the fuel tank cover.
4. Locate the grip warmer wire harness connectors, on both sides of the unit, inside the rubber boots (see adjacent photo).
