# Technical BULLETIN

2007: PZ50GT (8GK), PZ50FX (8GN), PZ50M (8GP), PZ50VT (8GJ)  
2008: PZ50 (8GC), PZ50GT (8GK), PZ50RT (8GN), PZ50MT (8GP), PZ50VT (8GJ)  
2009: PZ50 (8GC), PZ50GT (8GK), PZ50RT (8GN), PZ50MT (8GP), PZ50VT (8GJ)  
Ground Failure at Joint Connector

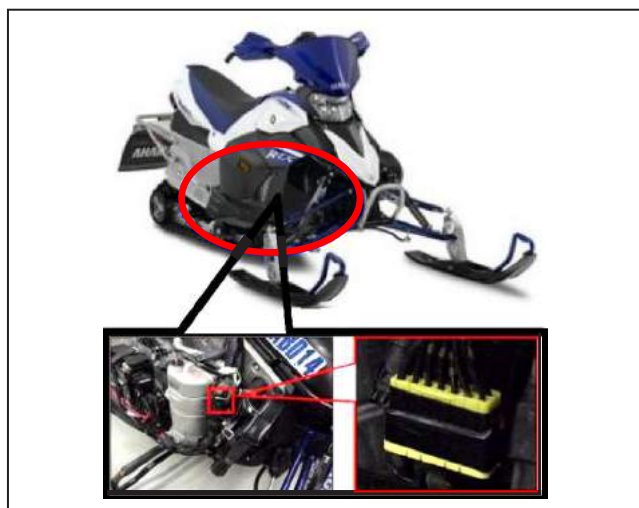
**Symptom:** The engine does not start.

**Cause:** Ground wires for multiple circuits are routed to a single 14-pin connector. In some conditions, the current in the wires may generate enough heat to damage the connector and cause an open in one or more ground circuits, resulting in a no-start situation.

**Remedy:** The installation of a ground wire sub-harness will distribute the current to a greater number of wires and reduce heat levels at the connector.

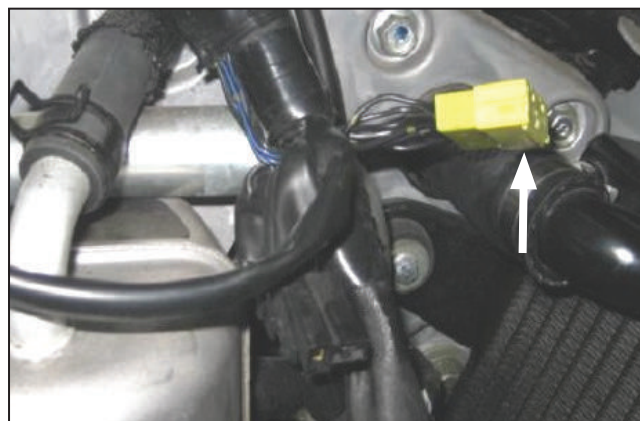
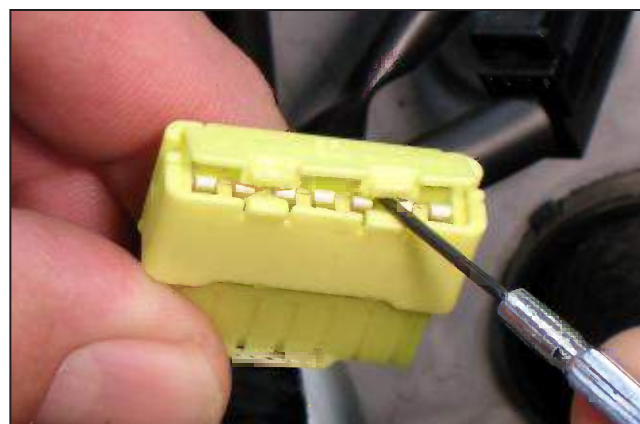
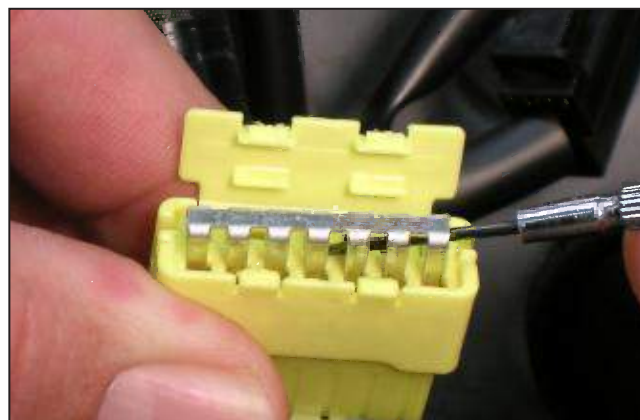
2. Remove the vinyl tape from the 14-pin yellow bus bar connector.
3. Inspect the existing yellow connector and terminals:
  - Unlock the top cover of the yellow connector by using a small screwdriver or equivalent to pry the two tabs.
  - Remove the metal bus bar by prying each end of the bar and lifting the bar out.
  - Closely inspect the inside and outside of the yellow connector for heat related damage.

**If no damage to the connector, proceed to step 4.**

**If the connector is damaged but can still be disassembled and no more than one wire is damaged by heat, proceed to step 7.**

**If two or more ground wires are damaged or if the yellow connector is damaged to the point where disassembly is not possible, contact your RTA for further instructions.**

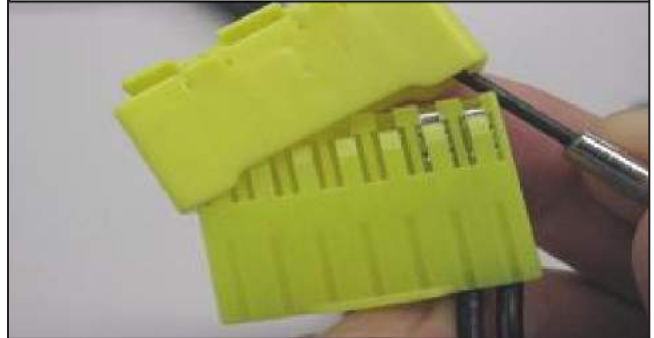
REMOVE TOP COVER.

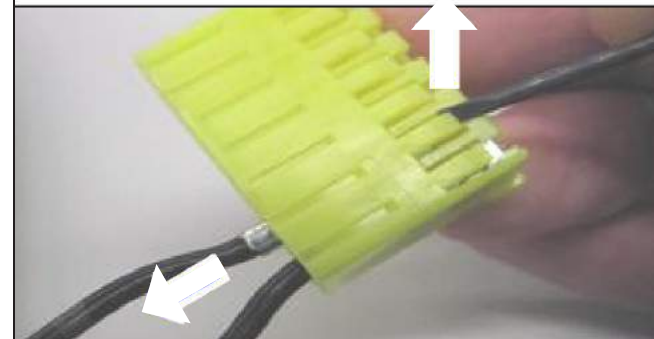
LIFT UP YELLOW TAB AND PULL WIRE OUT.

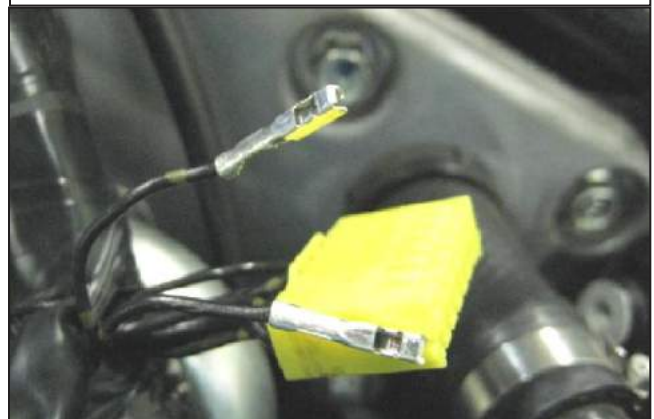
MOVE WIRES #5 AND #6 TO 6-PIN CONNECTOR.

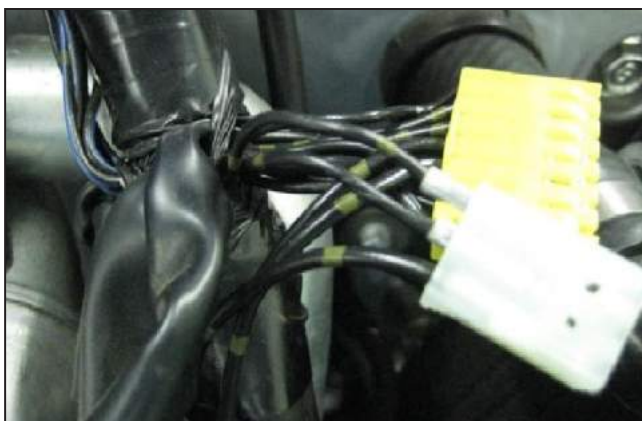
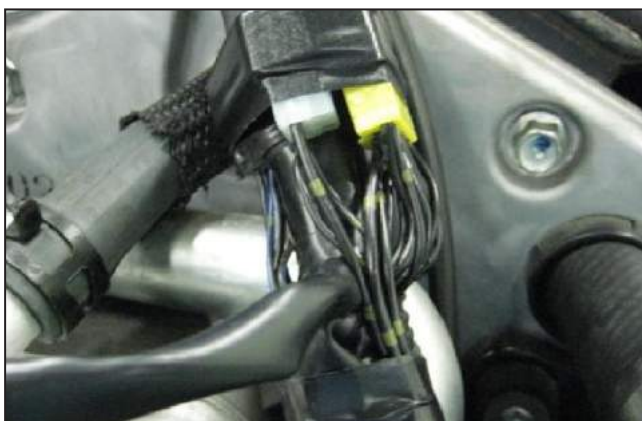
Ensure both connectors are positioned with the wires pointed down, then tape the sides and the top of the connectors (see adjacent photo).

12. Fasten both connectors to the main wiring harness using electrical tape.

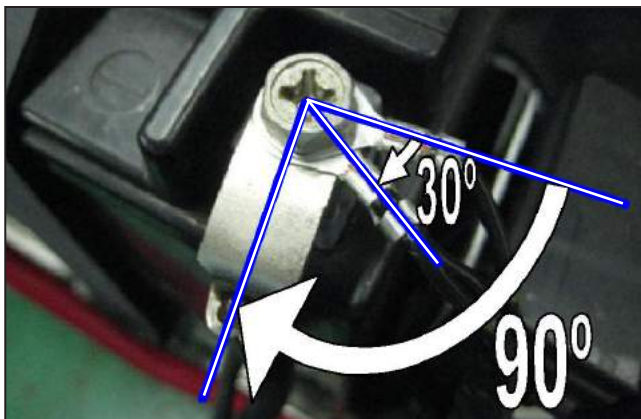
Make sure the wires are positioned on the negative battery terminal as shown in the adjacent photo to ensure a good ground.

14. Connect the two eyelet connectors to the negative battery terminal as illustrated.
