Technical BULLETIN

ALL 2008 PZ50GTX/MTX MODELS

Insufficient Heat Output from Grip Warmers

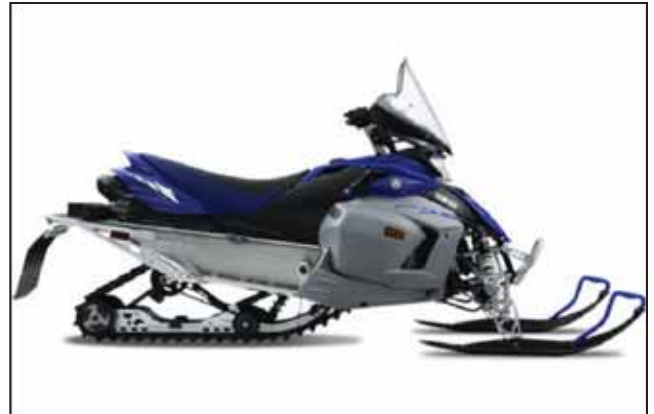
- Symptom:** On affected models, the grip warmer heat output may be insufficient at the higher heat settings.
- Cause:** During assembly, a sub-harness wire was not installed in the main wire harness.
- Remedy:** Install the missing grip warmer sub-harness to correct the wiring for the grip warmers during unit assembly and Pre-delivery Inspection (PDI) as per this bulletin.

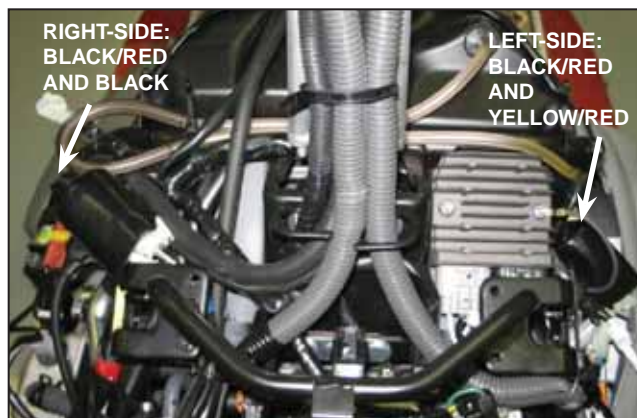
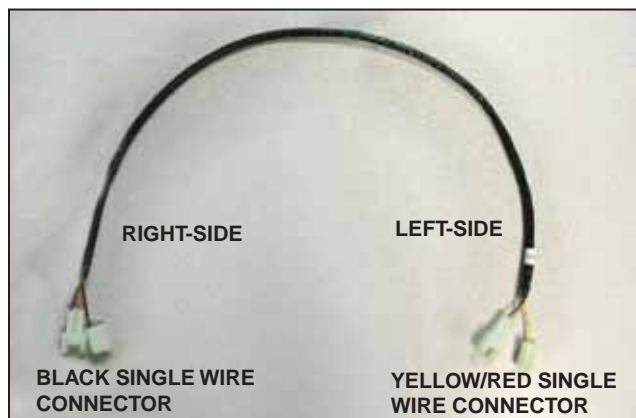
NOTE: The left side main harness connector wire colors are Black/Red and Yellow/Red. The right side are Black/Red and Black

1. Remove the windshield.
2. Remove the headlight cover. Remove the 3 bolts, on each side of the unit, to remove the left and right side panels.
3. Remove the headlight assembly and the fuel tank cover.
4. Locate the grip warmer wire harness connectors, on both sides of the unit, inside the rubber boots (see adjacent photo).

5. Disconnect the two grip warmer connectors.
6. Identify the left and right sides of the grip warmer sub-harness wire (see adjacent photo).
LEFT-SIDE: Yellow/Red single wire connector.
RIGHT-SIDE: Black single wire connector.
7. On the right side of the unit, insert the sub-harness through the back of the rubber boot, then connect it to the main harness and grip warmer as shown in the wiring illustration adjacent to step 10 on the next page.
