Technical BULLETIN

2007: PZ50GTW/FXW/MW/VTW MODELS

2008: PZ50GTX/RTX/MTX/VTX MODELS

Shifting Difficulties to and from Reverse

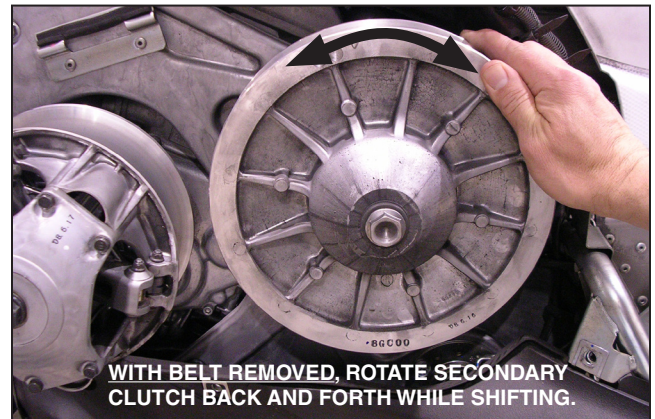
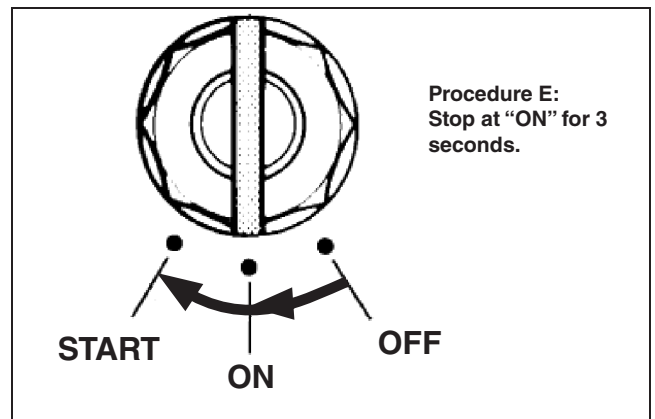
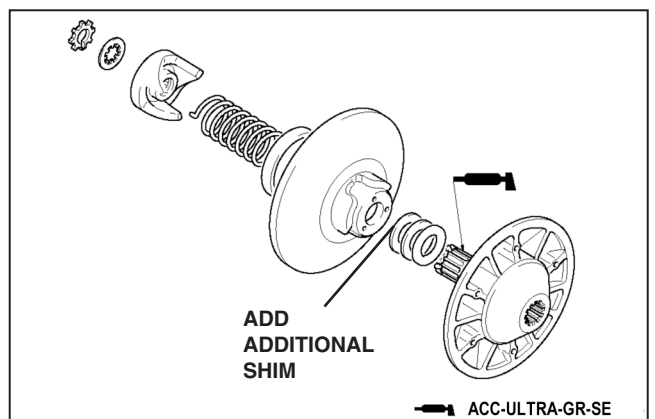
If the symptom still occurs after all other checks, a new drive belt (P/N: 8GK-17641-10-00) has been developed to improve the shifting function.

1. Ensure the ignition is OFF and the key has been removed. Apply the parking brake.
2. Remove the L/H side panel and drive belt guard.
3. Remove the drive belt.

4. Tag and hold the drive belt for 90 days from date of warranty request.
5. Remove and separate the secondary clutch assembly as per the Service Manual.

6. With the sheaves separated, add one secondary clutch shim (P/N: 90201-345G2-00) to the two already in place for a total of three shims.
7. Reassemble the secondary clutch assembly using a very light coat of Ultramatic Grease (P/N: ACC-ULTRA-GR-SE) on the secondary slide sheave bushing only. Confirm proper secondary spring location specification.
