# Technical BULLETIN

2007: PZ50GT (8GK), PZ50FX (8GN), PZ50M (8GP), PZ50VT (8GJ)  
2008: PZ50 (8GC), PZ50GT (8GK), PZ50RT (8GN), PZ50MT (8GP), PZ50VT (8GJ)  
2009: PZ50 (8GC), PZ50GT (8GK), PZ50RT (8GN), PZ50MT (8GP), PZ50VT (8GJ)  
Ground Failure at Joint Connector

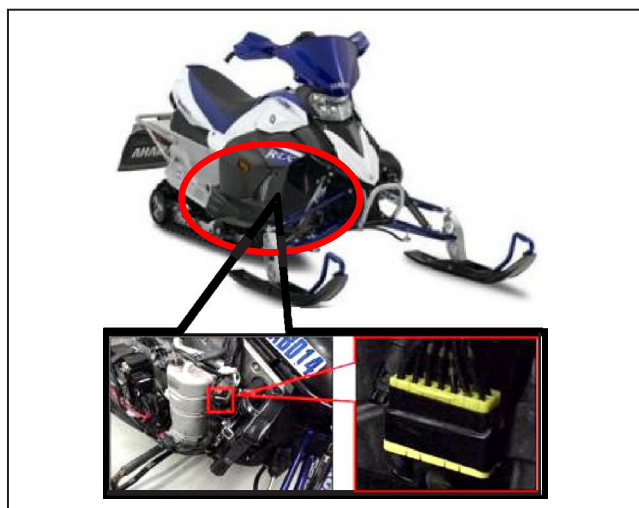
**Symptom:** The engine does not start.

**Cause:** Ground wires for multiple circuits are routed to a single 14-pin connector. In some conditions, the current in the wires may generate enough heat to damage the connector and cause an open in one or more ground circuits, resulting in a no-start situation.

**Remedy:** The installation of a ground wire sub-harness will distribute the current to a greater number of wires and reduce heat levels at the connector.

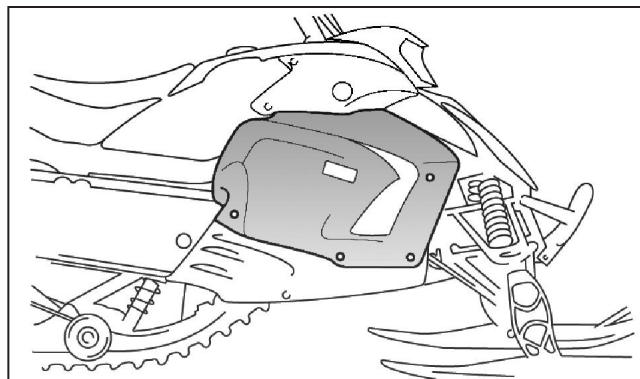
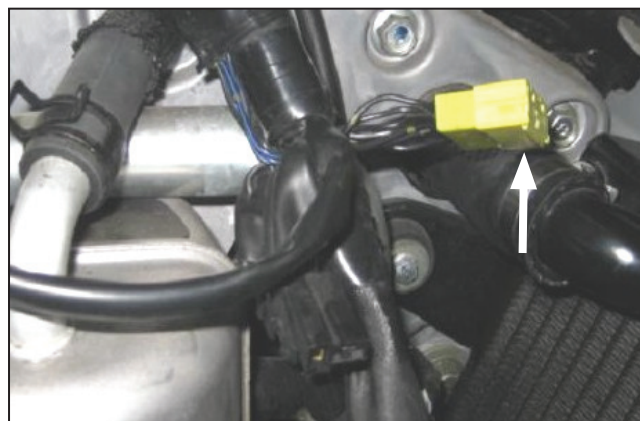
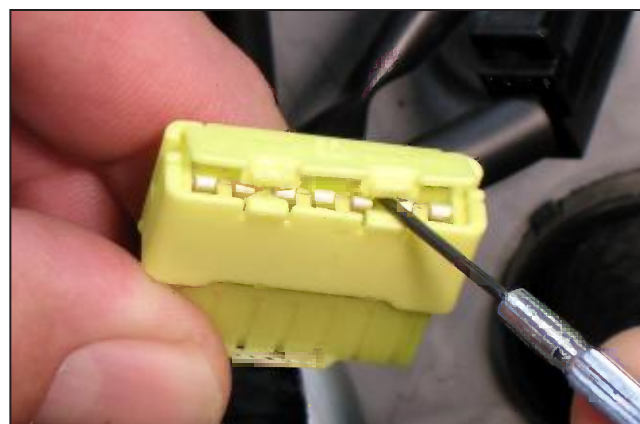
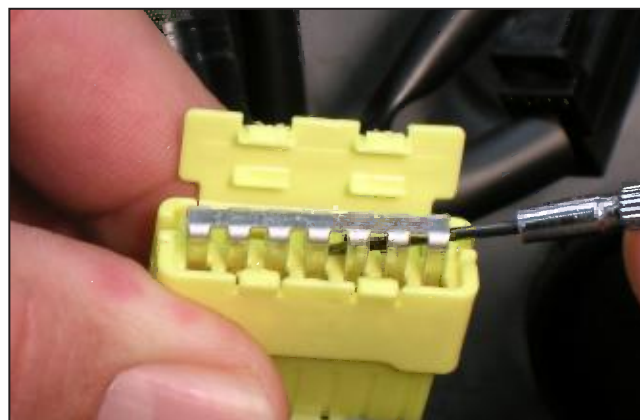
2. Remove the vinyl tape from the 14-pin yellow bus bar connector.
3. Inspect the existing yellow connector and terminals:
  - Unlock the top cover of the yellow connector by using a small screwdriver or equivalent to pry the two tabs.
  - Remove the metal bus bar by prying each end of the bar and lifting the bar out.
  - Closely inspect the inside and outside of the yellow connector for heat related damage.

**If no damage to the connector, proceed to step 4.**

**If the connector is damaged but can still be disassembled and no more than one wire is damaged by heat, proceed to step 7.**

**If two or more ground wires are damaged or if the yellow connector is damaged to the point where disassembly is not possible, contact your RTA for further instructions.**
