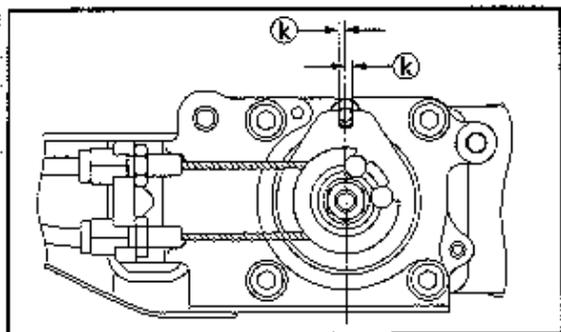
- i. Check that the $\varnothing 4$ pin (93604-29184) can be inserted into the boss of the EXUP valve housing. If the rod cannot be inserted, repeat the procedure from step (a).
- j. Tighten the locknut, and then restore the rubber cover to its original position.
- k. Activate the diagnostic mode and select the diagnostic code number d: 53.
Refer to "DIAGNOSTIC MODE".
- l. Again, check that the $\varnothing 4$ pin (93604-29184) can be inserted into the boss of the EXUP valve housing. If the rod cannot be inserted, repeat the procedure from step (a).

The center of the notch of the EXUP valve pulley and the center of the boss of the EXUP valve housing may be misaligned up to 2 mm (0.08 in).

(k) 2 mm (0.08 in)

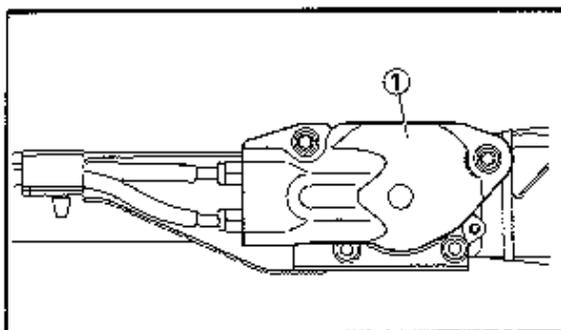
5. Install:
 - EXUP valve pulley cover ①

EXUP valve pulley cover bolt:
10 Nm (1.0 m•kgf, 7.2 ft•lbf)
