Technical BULLETIN

2007 PZ50W/FXW/GTW/MW/VTW

Hard Starting in Extreme Cold Temperatures

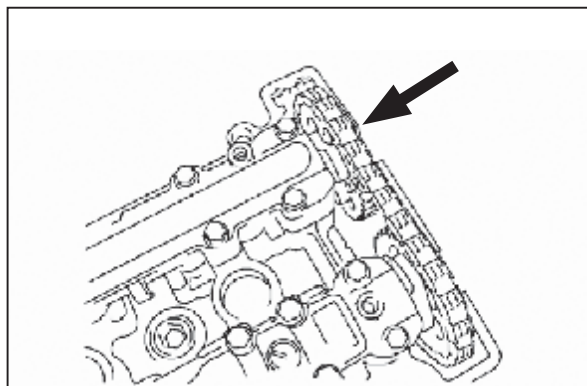
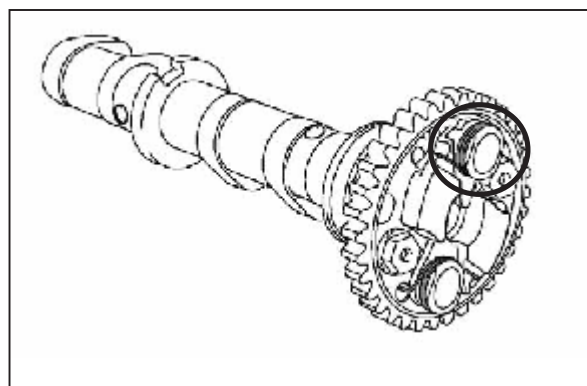
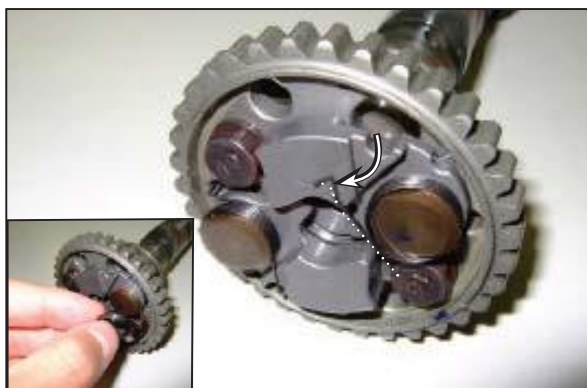
NOTE: Removing the camshaft is not required. A removed camshaft is illustrated as an example.

6. Remove the decompression spring as shown in the adjacent photo. Take care not to drop the spring into the engine.

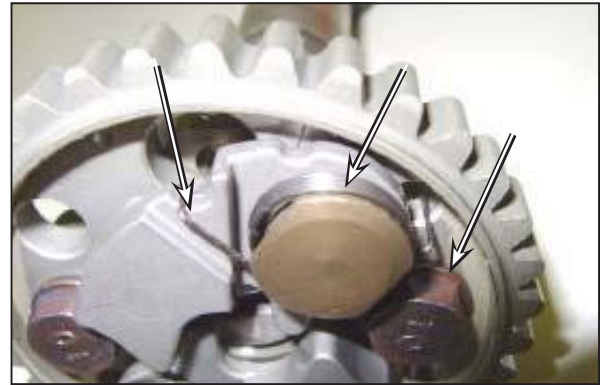
NOTE: Check that the spring is properly installed as shown in the adjacent photo.

8. Using the primary clutch, turn the engine in the normal (clockwise) direction of rotation to access the other spring. Install the second spring.

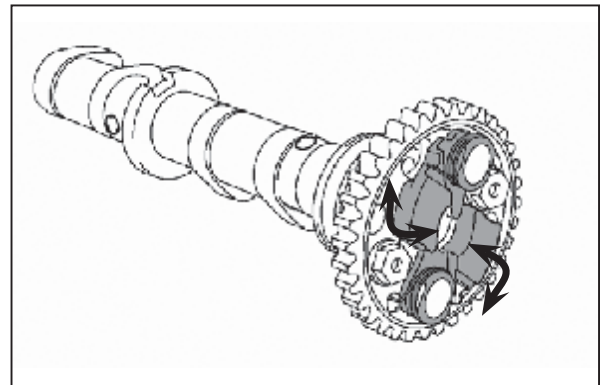
9. Check the decompression operation. By moving the weights outward by hand, when working correctly, the weights will return to their initial position.

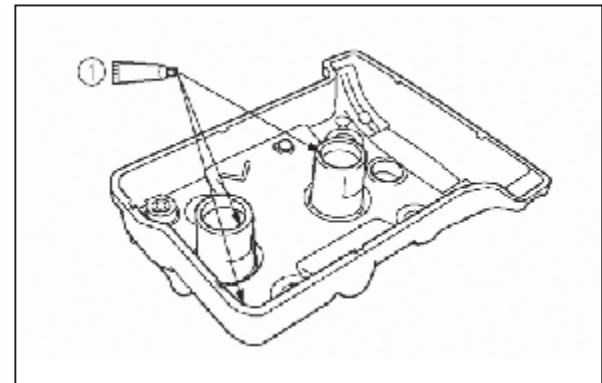
Apply Yamabond 4 Motorsports to the cover ① surface and the mating surfaces of the cylinder head gasket and cylinder head ②.

**Yamabond 4 Motorsports:
ACC-BOND4-MC-00**

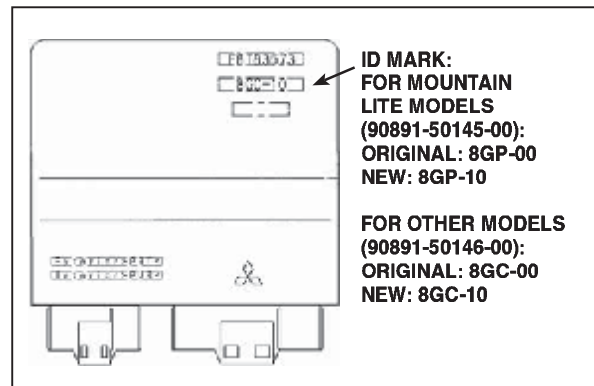
If you encounter an unfamiliar unit and you are unsure if the unit has been modified, check the ECU (see adjacent illustration).
