Technical BULLETIN

2007: PZ50GTW/FXW/MW/VTW MODELS

2008: PZ50GTX/RTX/MTX/VTX MODELS

Shifting Difficulties to and from Reverse

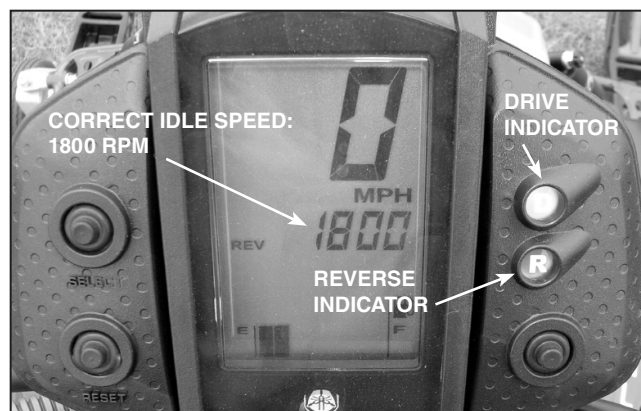
Proper Function of Drive / Reverse Indicator Lights and Reverse Buzzer

Shifting to Reverse:

- When shifting to reverse, the reverse indicator light will flash and the reverse buzzer will beep in an uneven short/long pattern.
- When shifting is completed, the reverse indicator light will stay on constant (no flashing) and the reverse buzzer will beep evenly.

Shifting to Drive:

- When shifting to drive, the drive indicator light will flash and the reverse buzzer will stop beeping.
- When shifting is completed, the drive indicator light will stay on constant (no flashing).
