2007 Snowmobile Technical Update

2007 RX10GT, RXW10GT

Ohlins EC Shock Wiring Harness, Routing and Clamping

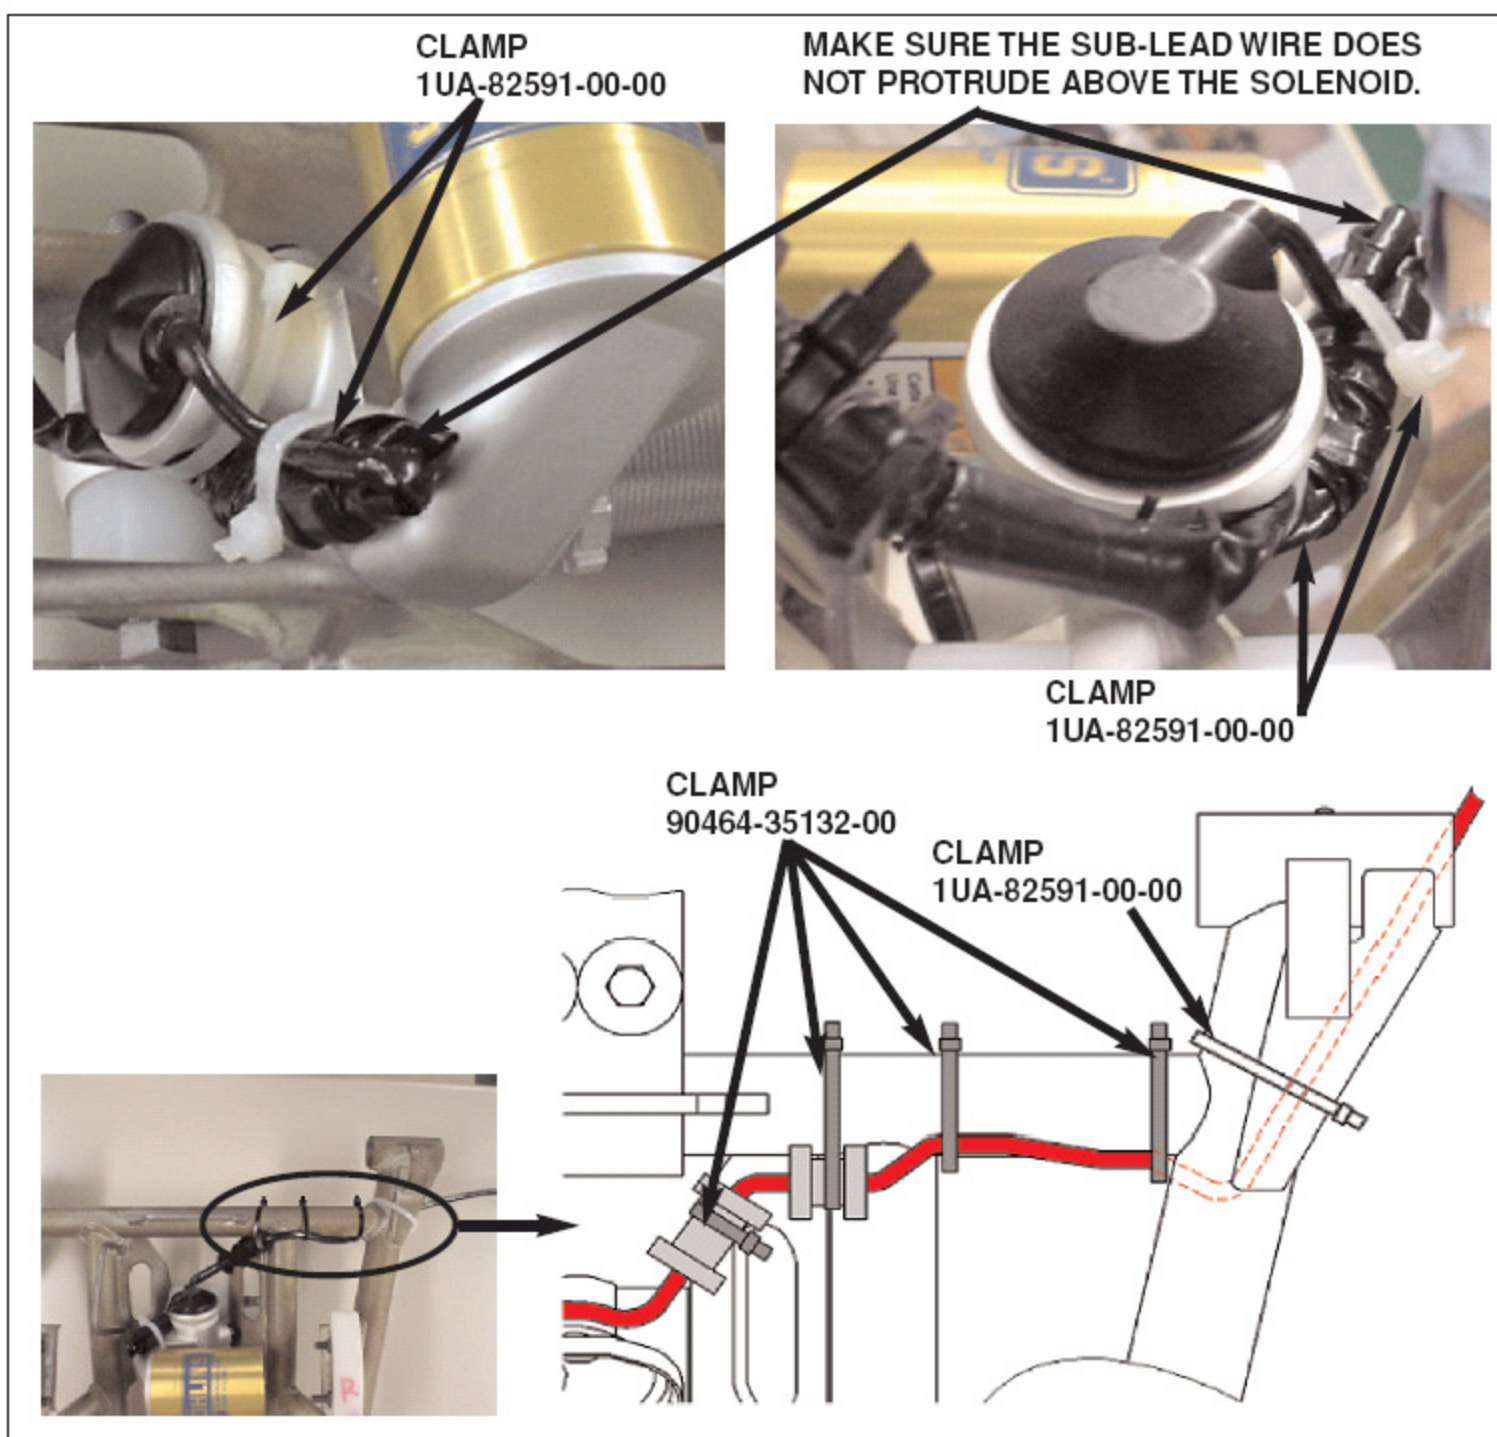
- On 2007 Ohlins EC models, the solenoid sub-lead harness routing and clamps have been changed to reduce the chance of sub-lead harness damage if the suspension is heavily bottomed.
- Plastic protective boot over the connector is no longer used.
- Solenoid harness routing and clamping changed at the solenoid to prevent the wires from protruding above the solenoid and contacting the track during hard bottoming.
- Sub-lead harness routing and clamping to the suspension arm changed.
- New wider plastic clamp, p/n 90464-35132, to better secure the harness to the suspension arm.
